# FACILITIES MANAGEMENT IN THE PUBLIC HOUSING ESTATE IN LAGOS NIGERIAN: IMPLICATIONS FOR SUSTAINABLE HOUSING DEVELOPMENT

Fagbohun, P. O.; Adedokun, T. A.; Oladiboye, E. O.; Adejugbagbe, J. A.

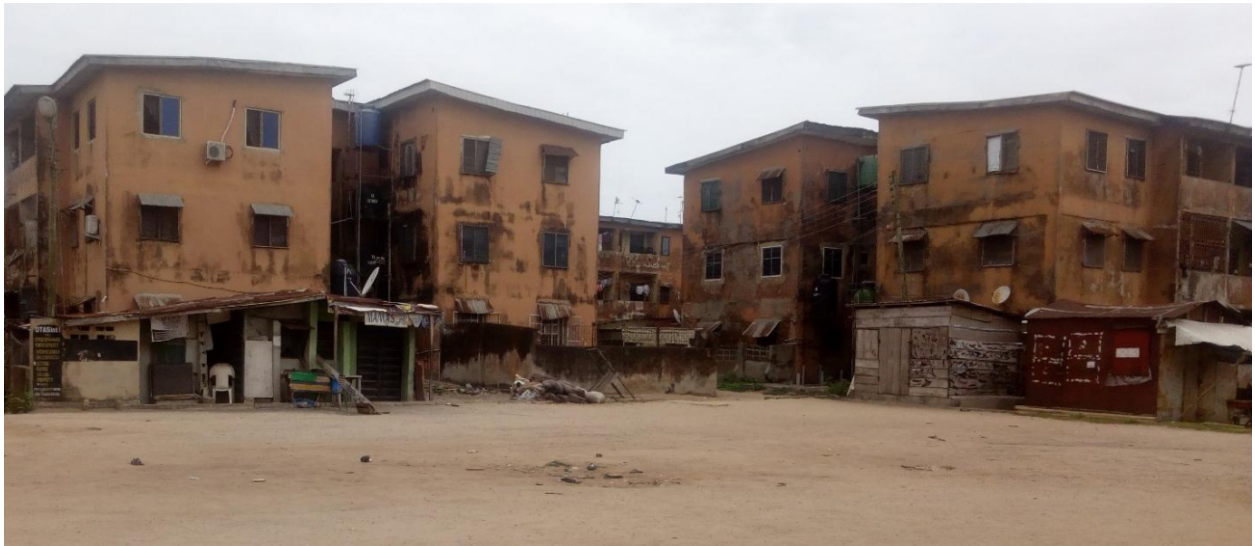
environment was good. Plate 1 is a picture of some buildings investigated, which describes the use of open space and general aesthetic condition of the study area.

Plate 1: Abuse Use of Open Space and Poor Physical Condition in the Study Area  
Source: Field Survey (2021)

- The condition of buildings inspected was not in conformity with good housing quality, in such areas as roof, wall, painting, drainage and open space. Hence plate 1, depicts the overall physical outlook of the residential buildings in the study area. The study found that there was high incident of hiring unqualified personnel, which was 71.29% of those who handled repairs and maintenance works on the sampled buildings. Hence management of the housing area was in the hand of individual flat occupants. In view of this, repair and maintenance were not properly handled.
